Sub: Failure analysis of Super heater coil, SH External Deposit and Wood chips collected from 120TPH boiler of BASL - reg.  
Ref.: MOM dated 18.08.2004 at BASL.

**BHEL: TRICHY-14  
PLANT LABORATORY**

INV144/04

ISSUED TO	DGM: FES (Attn. Sri.U.Anthonisamy)
REF NO	FES: TS: C.LAB: 3340 dt. 27.08.04
PROJECT	M/s. Bannari Amman Sugars Ltd, Sathyamanagalam UNIT 1 120 TPH
COMPONENT	Primary Superheater coil - 1 No (Assembly 17) Platen final Super Heater Coil unfailed - 1 No (Assembly10)
MATERIAL SIZE AND SPECN	Dia 51 x 5.6 mm SA 213 T91
WORKING TEMP & PRESSURE	510° C 90.5kg/cm <sup>2</sup>
SYN.DATE SERVIE HOURS	26 <sup>th</sup> August 2002 16,000 Hours

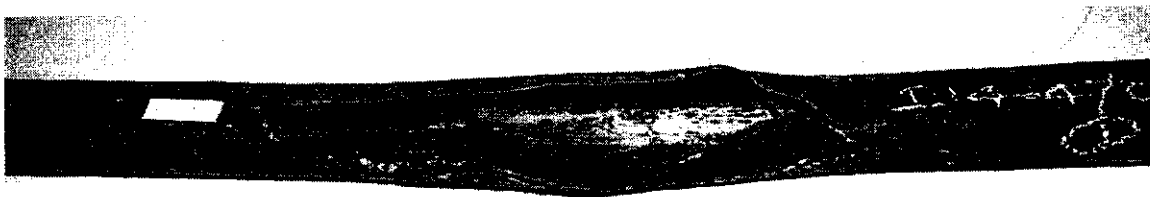
Photo1

**Tube No.1:** The tube has opened up with thin lips. Wall thinning and metal wastage are observed in the opened up region. Oxide scale seen on ID and OD surfaces (Photo1). Mild pitting is seen on the OD surface.

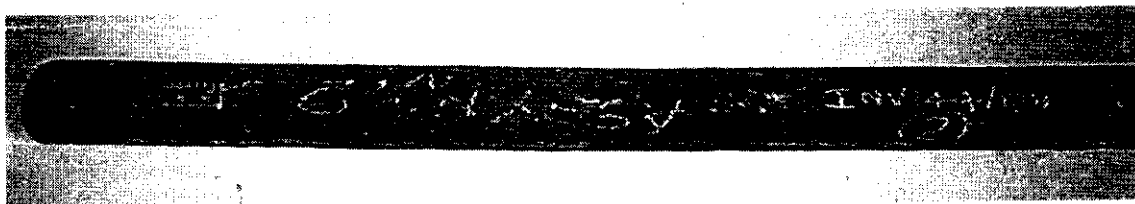
Photo 2

**Tube No.2:** Unfailed tube. Oxide scale seen on ID and OD surfaces (Photo2).
