**Monitoring report form for CDM project activity
(Version 08.0)**

MONITORING REPORT

Title of the project activity	Reducing Gas Leakages within the Jalalabad Gas Distribution Network in Bangladesh		
UNFCCC reference number of the project activity	10561		
Version number of the PDD applicable to this monitoring report	Version 4		
Version number of this monitoring report	1		
Completion date of this monitoring report	30/05/2021		
Monitoring period number	2		
Duration of this monitoring period	30/10/2020- 31/12/2020 (Including both days)		
Monitoring report number for this monitoring period	1		
Project participants	EcoGas Asia Ltd.		
Host Party	People's Republic of Bangladesh		
Applied methodologies and standardized baselines	Leak detection and repair in gas production, processing, transmission, storage and distribution systems and in refinery facilities" AM0023 (Version 04.0.0) No standardized baseline was applied		
Sectoral scopes	Sectoral Scope 10 – Fugitive emissions from fuels (solid, oil and gas)

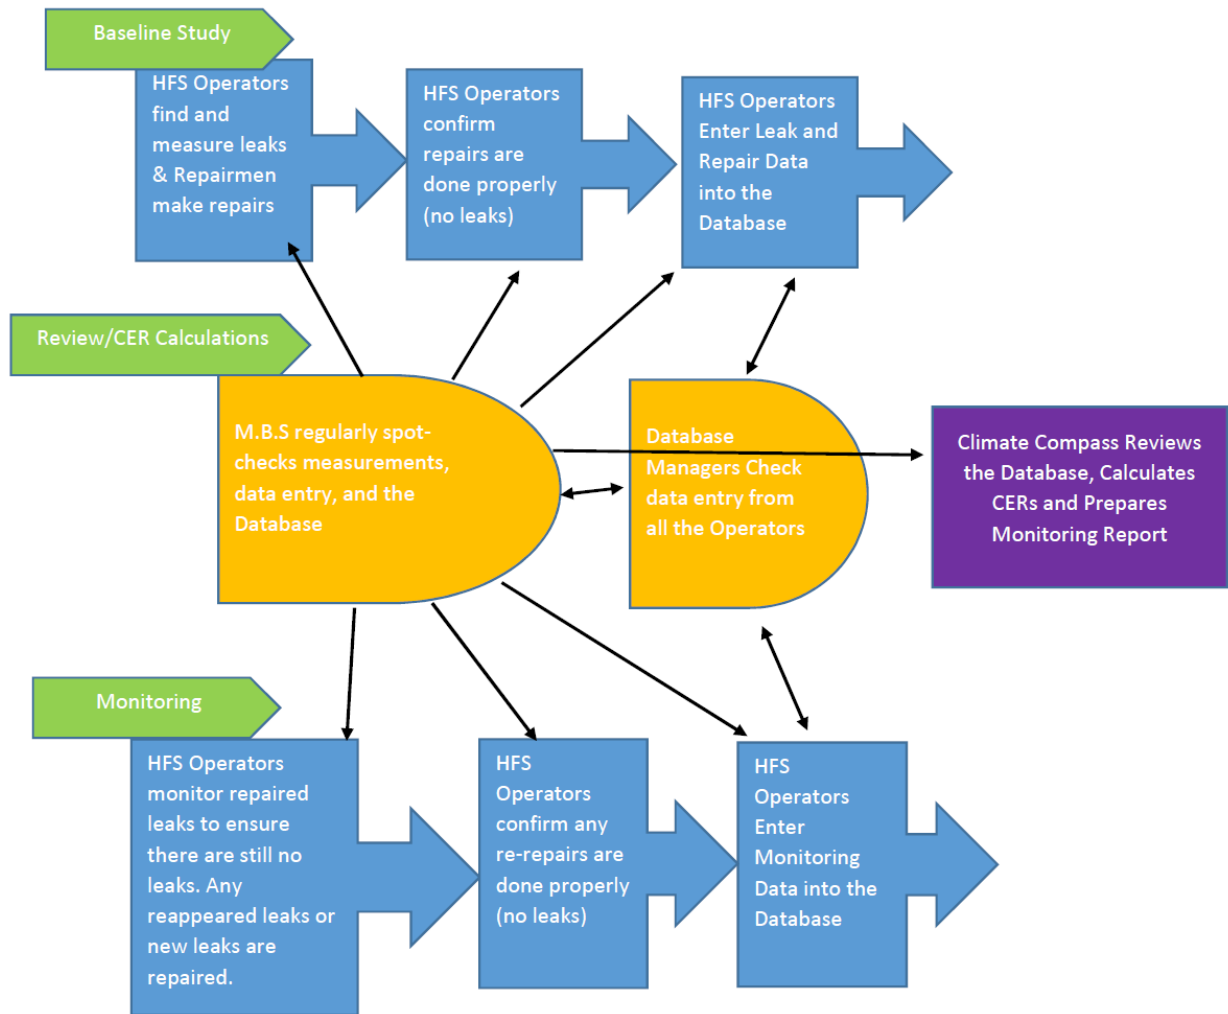
The flow of data in the project occurs as follows:
