Monitoring report form for CDM project activity
(Version 08.0)

MONITORING REPORT

Title of the project activity	Reducing Gas Leakages within the Jalalabad Gas Distribution Network in Bangladesh		
UNFCCC reference number of the project activity	10561		
Version number of the PDD applicable to this monitoring report	Version 4		
Version number of this monitoring report	1		
Completion date of this monitoring report	07/09/2021		
Monitoring period number	2		
Duration of this monitoring period	30/10/2020- 20/08/2021 (Including both days)		
Monitoring report number for this monitoring period	1		
Project participants	EcoGas Asia Ltd.		
Host Party	People's Republic of Bangladesh		
Applied methodologies and standardized baselines	Leak detection and repair in gas production, processing, transmission, storage and distribution systems and in refinery facilities" AM0023 (Version 04.0.0) No standardized baseline was applied		
Sectoral scopes	Sectoral Scope 10 – Fugitive emissions from fuels (solid, oil and gas)

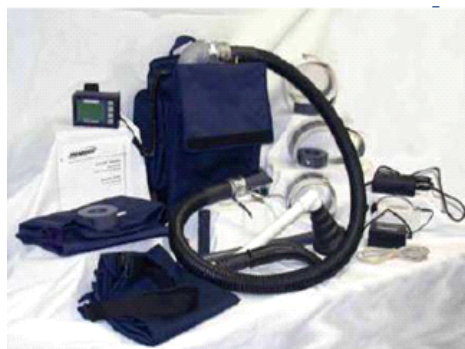
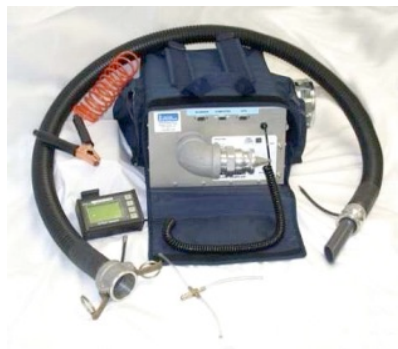
High Flow Sampler

Gas Surveyor 500

- The measurement method (Leaks may have been initially detected using Gas Surveyors. Once a leak was detected, all measurements for leak flow rate were taken using Hi-Flow Samplers, each Hi-Flow Sampler unit was assigned a number and the unit responsible for each measurement was thereby recorded. Furthermore, Hi-Flow Samplers recorded each measurement with a number between 1 and 999; the number corresponding to each measurement of leak flow rate is recorded in the Project Database. After the leak was repaired, the Repair Team used a soap solution to check the quality of the repair.

Monitoring equipment	Manufacturer procedures applied. Measurements with Hi-Flow™ Sampler are automatically adjusted to the methane content, temperature and pressure and, thus, will directly yield methane leak flow rates.
Measuring/reading/recording frequency:	At least once per monitoring period
Calculation method (if applicable):	Not Applicable
QA/QC procedures:	The high flow sampler is calibrated and double checked every 30 days while in use with the date and signature of the person in-charge of the calibration recorded in a calibration log.
Purpose of data/parameter:	This value applies for the calculation of baseline and project emissions
Additional comments:	Values taken from Hi-Flow sampler measurements.
