**Monitoring report form for CDM project activity
(Version 08.0)**

Title of the project activity	Reducing Gas Leakages within the Pashchimanchal Gas Distribution Network in Bangladesh		
UNFCCC reference number of the project activity	10562		
Version number of the PDD applicable to this monitoring report	Version 4		
Version number of this monitoring report	1		
Completion date of this monitoring report	30/05/2021		
Monitoring period number	2		
Duration of this monitoring period	20/10/2020- 31/12/2020 (including both days)		
Monitoring report number for this monitoring period	1		
Project participants	EcoGas Asia Ltd.		
Host Party	People's Republic of Bangladesh		
Applied methodologies and standardized baselines	Leak detection and repair in gas production, processing, transmission, storage and distribution systems and in refinery facilities" AM0023 (Version 04.0.0) No standardized baseline was applied		
Sectoral scopes	Sectoral Scope 10 – Fugitive emissions from fuels (solid, oil and gas)

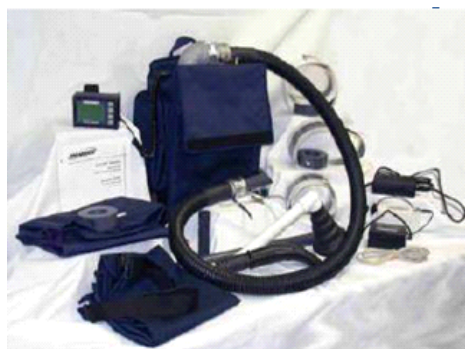
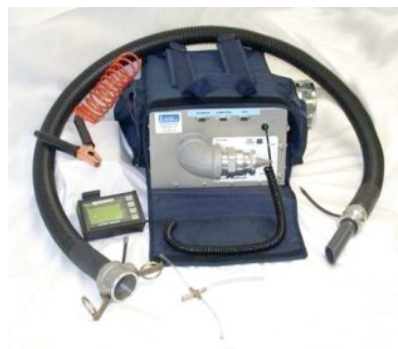
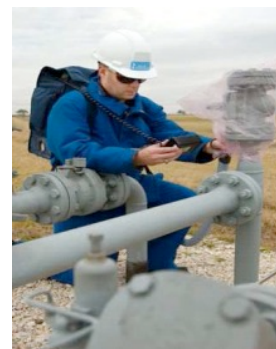
High Flow Sampler

Gas Surveyor 500

- The measurement method (Leaks may have been initially detected using Gas Surveyors. Once a leak was detected, all measurements for leak flow rate were taken using Hi-Flow Samplers, each Hi-Flow Sampler unit was assigned a number and the unit responsible for each measurement was thereby recorded. Furthermore, Hi-Flow Samplers recorded each measurement with a number between 1 and 999; the number corresponding to each measurement of leak flow rate is recorded in the Project Database. After the leak was repaired, the Repair Team used a soap solution to check the quality of the repair.
